Manhole Inspection Summary

Manhole # S31GG_055MH

Insp Date: **1/16/07 12:36 PM**

Location Address: **201 PARK AVE**

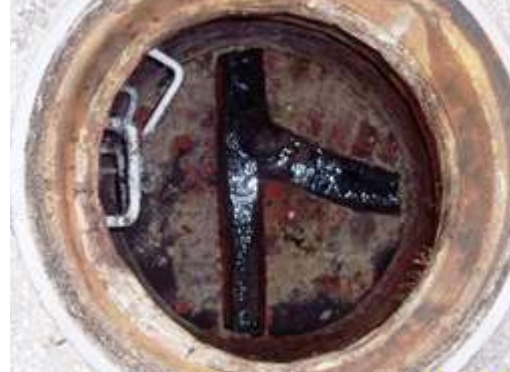
Top View

Evidence of surcharge - Bench debris.
Channel debris.

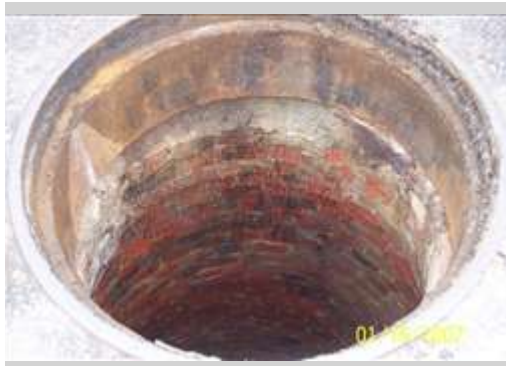
Defect

Frame leaks. Adjustment deterioration
and infiltration. Corbel and Barrel
infiltration.

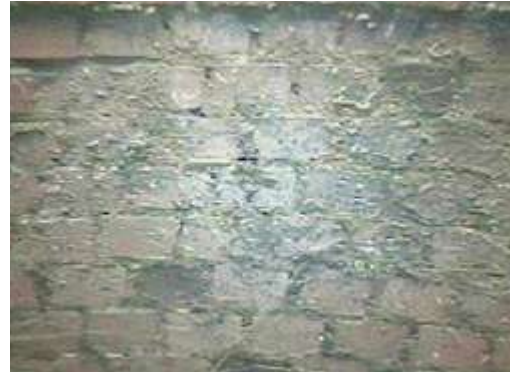
Defect

Barrel root intrusion and infiltration.

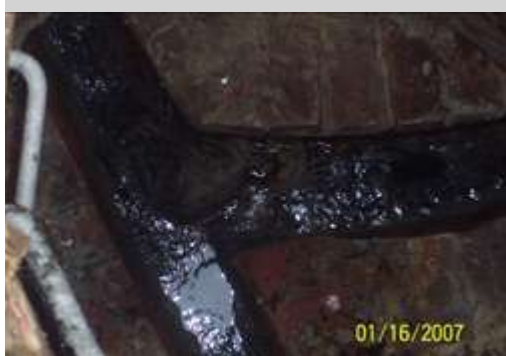
Defect

Channel debris.

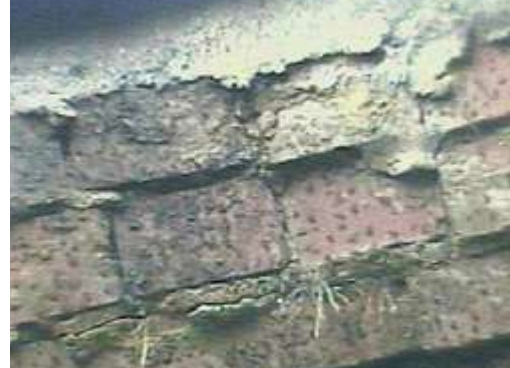
Defect

Adjustment root intrusion and infiltration.

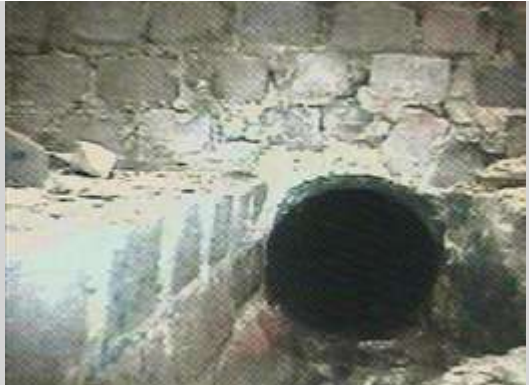
8 in. Circular Gravity Sewer Pipe Out @ 12 O'Clock

Barrel deterioration and infiltration.

Infiltration: **Evidence** Pipe Seal Cond: **Unknown**

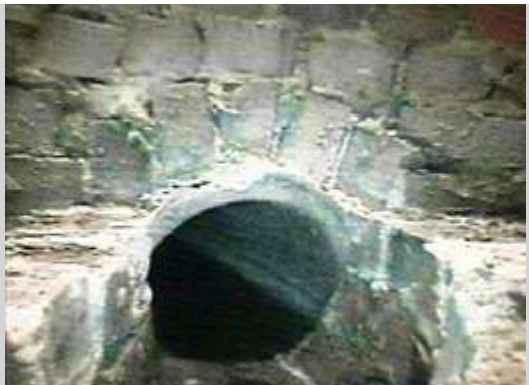
8 in. Circular Gravity Sewer Pipe In @ 3 O'Clock

Infiltration: **Evidence** Pipe Seal Cond: **Unknown**

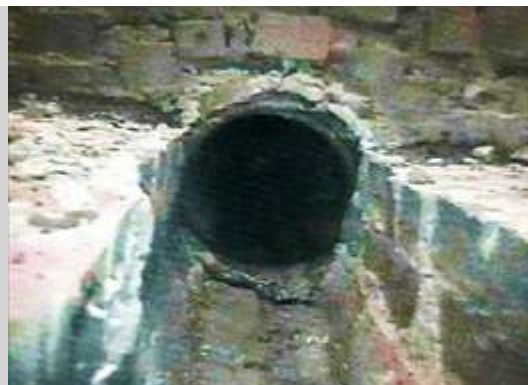
Pipe In @ 6 O'Clock

Barrel deterioration and infiltration.

Infiltration: **Evidence** Pipe Seal Cond: **Unknown**
